ROLLINSFORD DAM
NH 00396

PHASE I INSPECTION REPORT
NATIONAL DAM INSPECTION PROGRAM

DECEMBER 1979

Identification No.: NH00396
Name of Dam: Rollinsford Dam
Town: Rollinsford
County and State: Strafford County, New Hampshire
River: Salmon Falls River
Date of Inspection: October 25, 1979

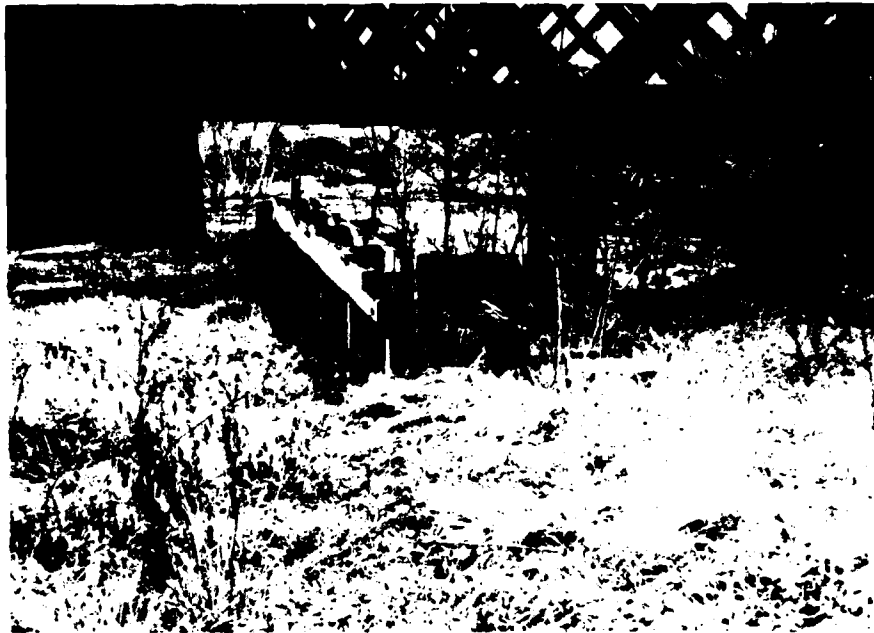
October 25, 1979
Figure 4 - View of the filled in approach channel
and gate structures.

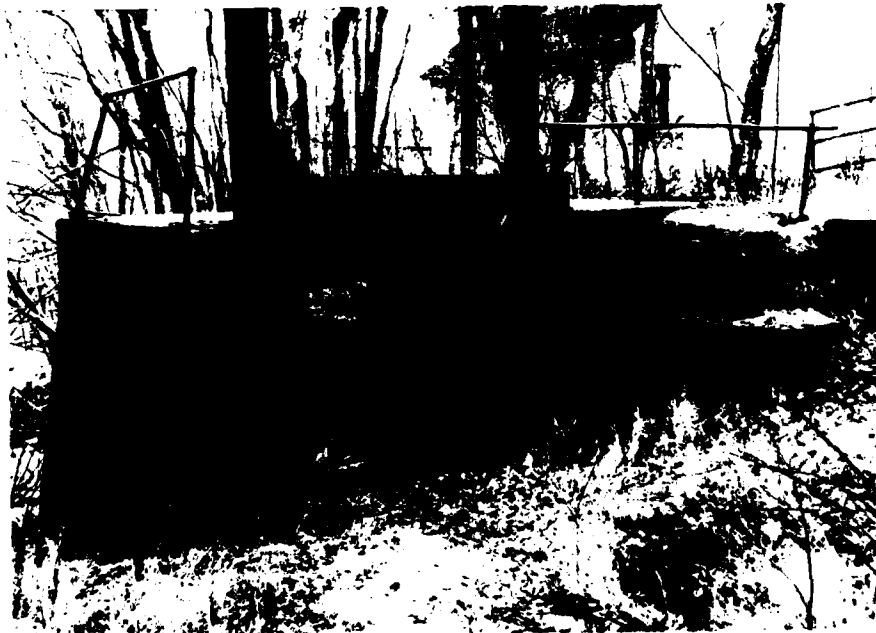
October 25, 1979
Figure 5 - Looking at an inoperable gate on the
southwest end of the dam.

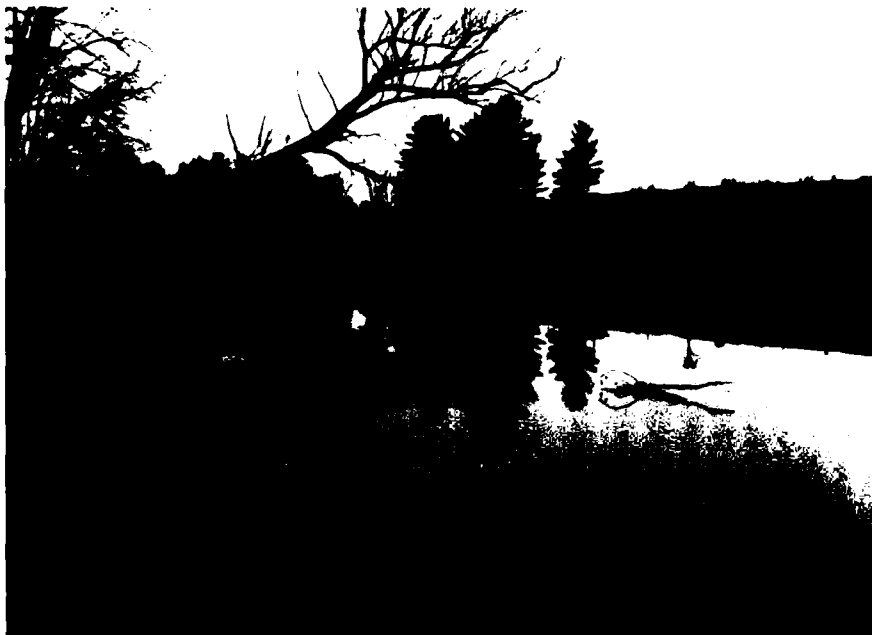
d. Reservoir. The watershed above the reservoir is gently to moderately sloping and partially wooded. (See Appendix C - Figure 10.) No evidence of significant sedimentation was observed.

October 25, 1979
 Figure 10 - Looking upstream into the reservoir from
 the southwest abutment.

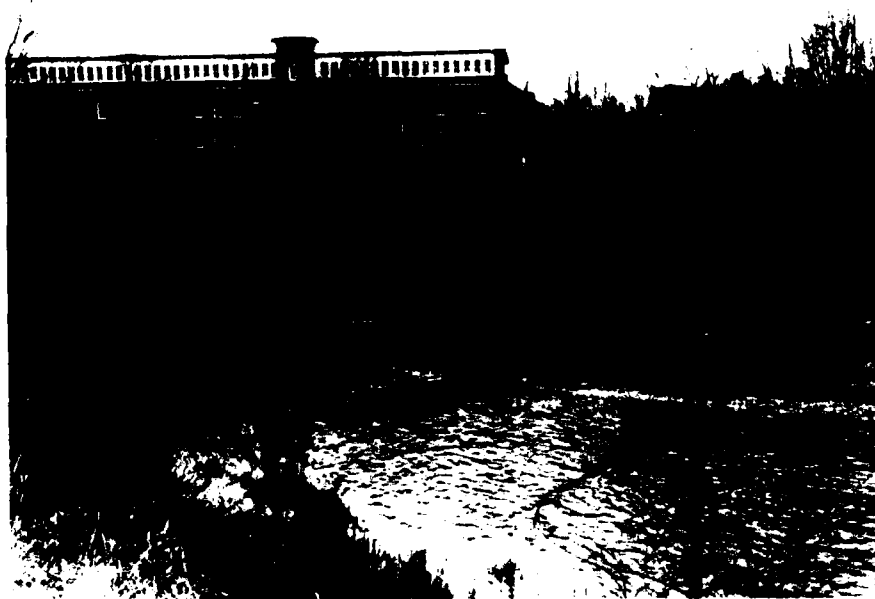
October 25, 1979
 Figure 11 - Looking downstream at the road crossing
 from the northeast discharge channel.
